**Flood Control Project Maintenance  
Levee Inspections**

## Maintenance Issue Types Only, Levee Inspection Report By Mile - Spring 2016

### Reclamation District No. 1000 Natomas

Waterway	Bank	Unit Miles	Inspection Start/End	Inspector
Unit No. 01 Sacramento River	Left	18.28	04/06/2016 04/06/2016	Sterling York

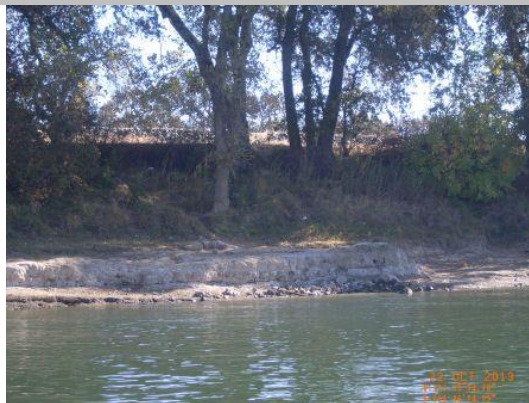
Photo 1 of 1 : SP\_2016\_RD1000\_31\_3\_20160307\_00003.jpg

LM Start	0.48	Rating **	M	Issue No.	3
LM End	0.61	Issue Type +	Ma	Location *	WS
Category	Supplemental			GPS Latitude/Longitude	
				Start	End
Item	2015 USACE Erosion Survey, DRAFT			38.774507 °	38.772921 °
				-121.598865 °	-121.597788 °
DWR ID	DWR_RD1000_01_s _ 2016_3				
Comment Code					
Inspector Comment					
1997 - Very cohesive toe. 2005 - Site was staked and rock was stockpiled along the top of the bank. 2010 - New adjacent levee under construction. 2011 - New animal burrow. 2015: No observed changes. [2015 Site ID: SAC_78-3_L]

USACE 2013 Photo #1

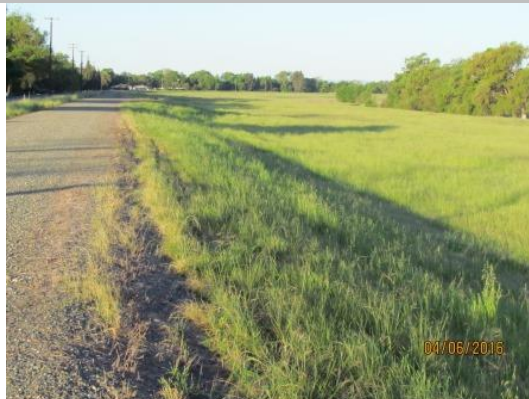
Photo 1 of 1 : SP\_2016\_RD1000\_31\_88\_20160418\_00051.jpg

LM Start	8.34	Rating **	M	Issue No.	88
LM End	11.90	Issue Type +	Ma	Location *	LS
Category	Earthen Levee			GPS Latitude/Longitude	
				Start	End
Item	Vegetation			38.673950 °	38.649536 °
				-121.624674 °	-121.578372 °
DWR ID	DWR_RD1000_01_s _ 2016_88				
Comment Code					
V1 : Control annual grass and weeds on the levee slopes and easements.					
Inspector Comment

Typical vegetation looking upstream on landside.

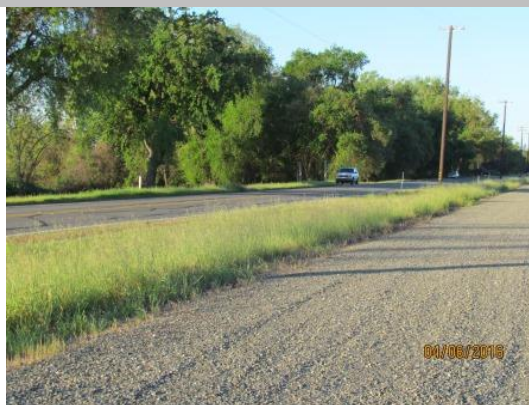
Photo 1 of 1 : SP\_2016\_RD1000\_31\_97\_20160418\_00052.jpg

LM Start	8.34	Rating **	M	Issue No.	97
LM End	11.90	Issue Type +	Ma	Location *	WS
Category	Earthen Levee			GPS Latitude/Longitude	
				Start	End
Item	Vegetation			38.673945 °	38.649537 °
				-121.624676 °	-121.578372 °
DWR ID	DWR_RD1000_01_s _ 2016_97				
Comment Code					
V1 : Control annual grass and weeds on the levee slopes and easements.					
Inspector Comment

Typical vegetation on waterside looking upstream.

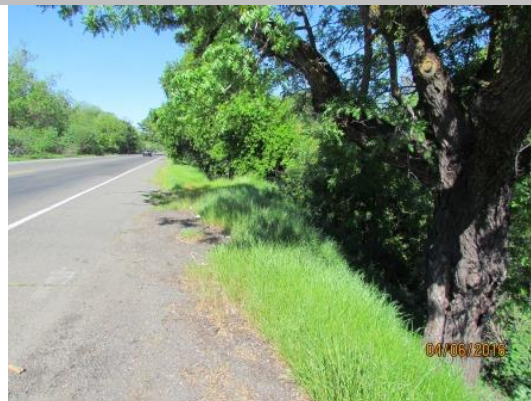
Photo 1 of 1 : SP\_2016\_RD1000\_32\_3\_20160418\_00005.jpg

LM Start	0.56	Rating **	M	Issue No.	3
LM End	1.49	Issue Type +	Ma	Location *	LS
Category	Earthen Levee			GPS Latitude/Longitude	
				Start	End
Item	Vegetation			38.607549 °	38.608041 °
				-121.501800 °	-121.484769 °
DWR ID	DWR_RD1000_02_s _ 2016_3				
Comment Code					
V1 : Control annual grass and weeds on the levee slopes and easements.					
Inspector Comment

Vegetation on landside looking downstream.

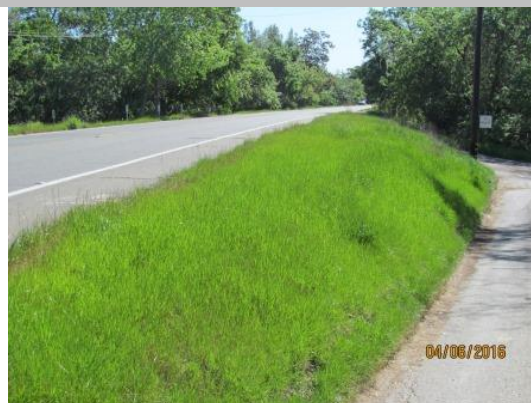
Photo 1 of 1 : SP\_2016\_RD1000\_32\_4\_20160418\_00006.jpg

LM Start	0.56	Rating **	M	Issue No.	4
LM End	1.49	Issue Type +	Ma	Location *	WS
Category	Earthen Levee			GPS Latitude/Longitude	
				Start	End
Item	Vegetation			38.607549 °	38.608040 °
				-121.501800 °	-121.484769 °
DWR ID	DWR_RD1000_02_s _ 2016_4				
Comment Code					
V1 : Control annual grass and weeds on the levee slopes and easements.					
Inspector Comment

Typical vegetation on the waterside looking upstream.

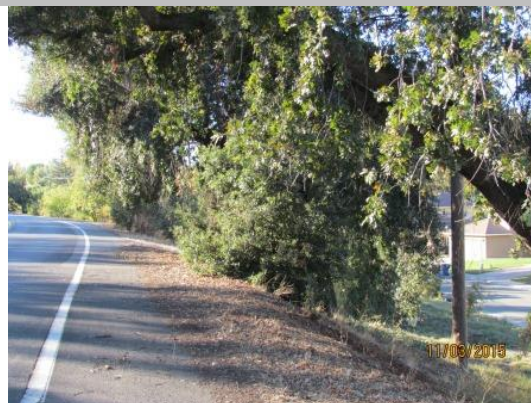
Photo 1 of 1 : SP\_2016\_RD1000\_32\_2\_20160307\_00004.jpg

LM Start	1.54	Rating **	M	Issue No.	2
LM End	1.61	Issue Type +	Ma	Location *	LS
Category	Earthen Levee			GPS Latitude/Longitude	
				Start	End
Item	Trim / Thin Trees			38.607978 °	38.607713 °
				-121.483858 °	-121.482524 °
DWR ID	DWR_RD1000_02_s _ 2014_2				
Comment Code					
T2 : Thin trees to allow visibility of the ground and room to flood fight.					
Inspector Comment					
Small trees 4" in diameter at chest height should be removed before they get to big.

View of the trees on the landside levee slope. Small trees 4" in diameter at chest height should be removed before they get to big.

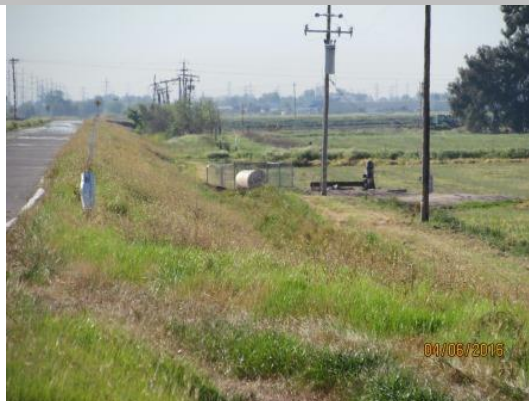
Photo 1 of 1 : SP\_2016\_RD1000\_33\_11\_20160418\_00015.jpg

LM Start	0.05	Rating **	M	Issue No.	11
LM End	15.81	Issue Type +	Ma	Location *	LS
Category	Earthen Levee			GPS Latitude/Longitude	
				Start	End
Item	Vegetation			38.606413 °	38.823595 °
				-121.469999 °	-121.527108 °
DWR ID	DWR_RD1000_03_s_2016_11				
Comment Code					
V1 : Control annual grass and weeds on the levee slopes and easements.					
Inspector Comment

Typical vegetation on the landside looking downstream.

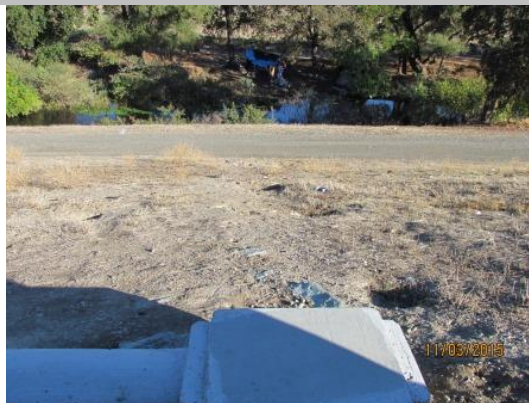
Photo 1 of 2 : SP\_2016\_RD1000\_33\_19\_20160307\_00013.jpg

LM Start	0.38	Rating **	M	Issue No.	19
LM End	0.38	Issue Type +	Ma	Location *	WS
Category	Earthen Levee			GPS Latitude/Longitude	
				Start	End
Item	Animal Control			38.610854 °	38.610854 °
				-121.467961 °	-121.467961 °
DWR ID	DWR_RD1000_03_f_2015_19				
Comment Code					
A1 : Exterminate rodents and backfill and compact or grout burrows.					
Inspector Comment

View of the rodent holes on the waterside levee slope.

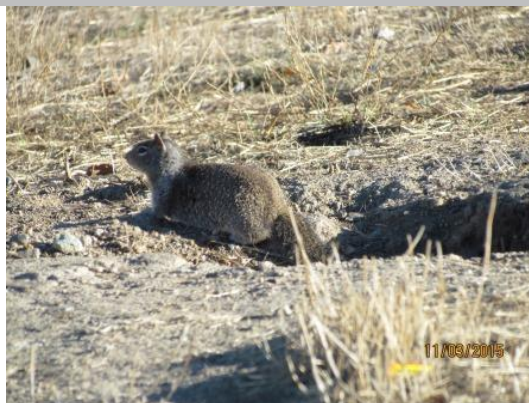
Photo 2 of 2 : SP\_2016\_RD1000\_33\_19\_20160307\_00014.jpg

View of the rodent on the waterside levee slope ready to retreat into the den, penetrating the levee prism.

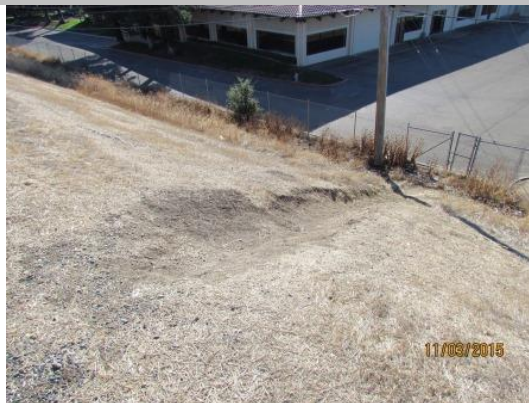
Photo 1 of 1 : SP\_2016\_RD1000\_33\_15\_20160307\_00012.jpg

LM Start	2.36	Rating **	M	Issue No.	15
LM End	2.36	Issue Type +	Ma	Location *	LS
Category	Earthen Levee			GPS Latitude/Longitude	
				Start	End
Item	Slope Stability			38.639326 °	38.639326 °
				-121.473107 °	-121.473107 °
DWR ID	DWR_RD1000_03_f_2015_15				
Comment Code					
S2 : Repair the levee slope damaged by foot traffic and prevent access where possible.					
Inspector Comment

View of the landside levee slope damaged by foot traffic.

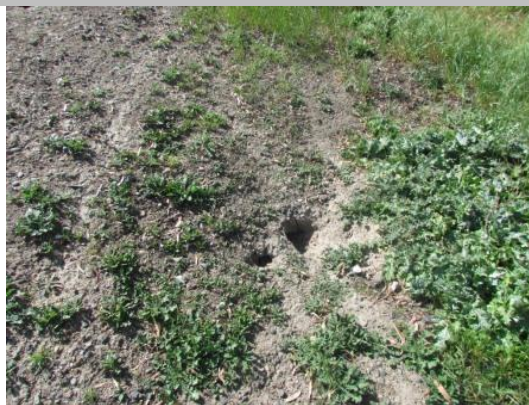
Photo 1 of 1 : SP\_2016\_RD1000\_33\_12\_20160307\_00010.jpg

LM Start	3.29	Rating **	A/W	Issue No.	12
LM End	3.29	Issue Type +	Ma	Location *	LS
Category	Earthen Levee			GPS Latitude/Longitude	
				Start	End
Item	Animal Control			38.652670 °	38.652670 °
				-121.475588 °	-121.475588 °
DWR ID	DWR_RD1000_03_s_2015_12				
Comment Code					
A3 : No rodents visible, but rodent burrows visible; need to backfill and compact or grout burrows.					
Inspector Comment

This photo was taken looking at the landside facing downstream.

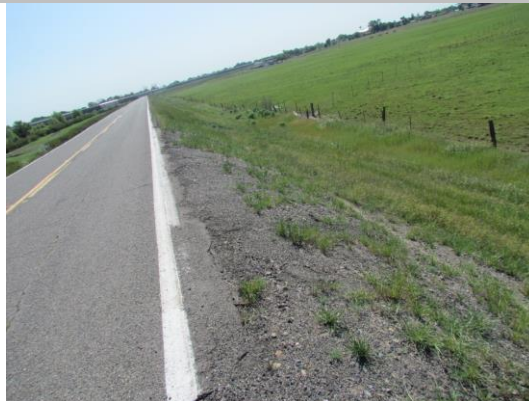
Photo 1 of 3 : SP\_2016\_RD1000\_33\_1\_20160307\_00001.jpg

LM Start	4.78	Rating **	A/W	Issue No.	1
LM End	4.89	Issue Type +	Ma	Location *	LS
Category	Earthen Levee			GPS Latitude/Longitude	
				Start	End
Item	Animal Control			38.672913 °	38.673685 °
				-121.481364 °	-121.483115 °
DWR ID	DWR_RD1000_03_f_2013_1				
Comment Code					
A1 : Exterminate rodents and backfill and compact or grout burrows.					
Inspector Comment

Updated view taken facing the landside looking upstream. Rodent holes have been filled and no new activity was observed.

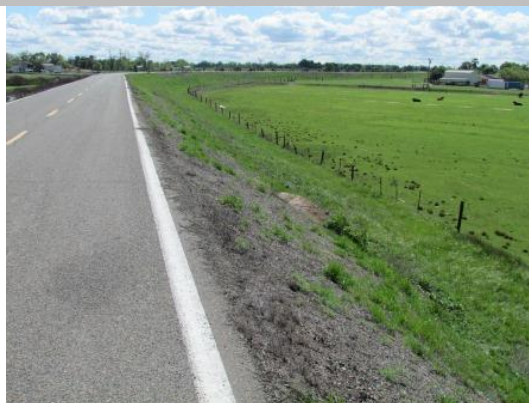
Photo 2 of 3 : SP\_2016\_RD1000\_33\_1\_20160307\_00002.jpg

This photo was taken from the crown facing south looking down the landward slope at a rodent hole requiring maintenance. Spring 2014.

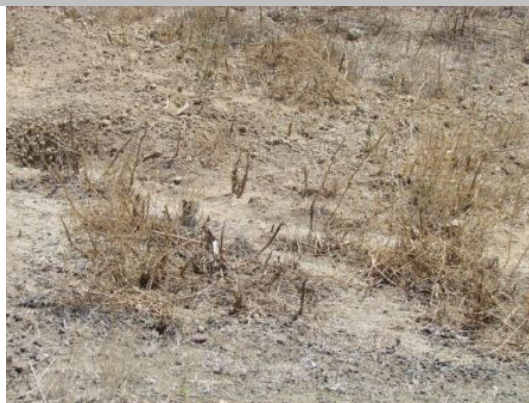
Photo 3 of 3 : SP\_2016\_RD1000\_33\_1\_20160307\_00003.jpg

This photo was taken from the levee crown looking down the landward slope at a squirrel poking its head out of a hole.

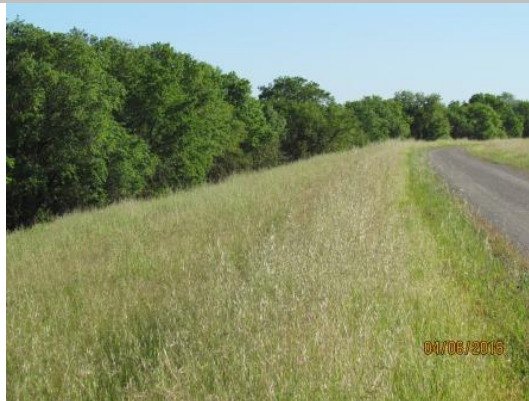
Photo 1 of 1 : SP\_2016\_RD1000\_34\_14\_20160418\_00001.jpg

LM Start	0.00	Rating **	M	Issue No.	14
LM End	4.18	Issue Type +	Ma	Location *	WS
Category	Earthen Levee			GPS Latitude/Longitude	
				Start	End
Item	Vegetation			38.802816 °	38.782128 °
				-121.573540 °	-121.603074 °
DWR ID	DWR_RD1000_04_s_2016_14				
Comment Code					
V1 : Control annual grass and weeds on the levee slopes and easements.					
Inspector Comment

Typical vegetation, looking upstream on the waterside.

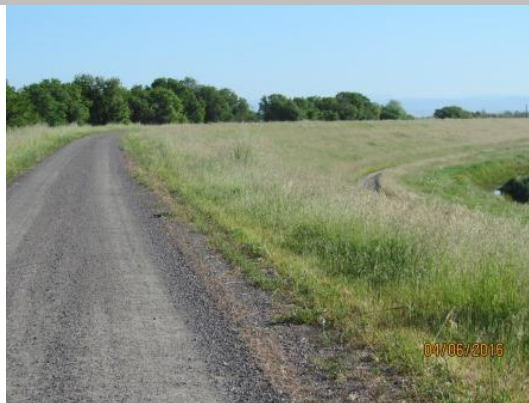
Photo 1 of 1 : SP\_2016\_RD1000\_34\_13\_20160418\_00002.jpg

LM Start	0.00	Rating **	M	Issue No.	13
LM End	4.18	Issue Type +	Ma	Location *	LS
Category	Earthen Levee			GPS Latitude/Longitude	
				Start	End
Item	Vegetation			38.802816 °	38.782128 °
				-121.573540 °	-121.603075 °
DWR ID	DWR_RD1000_04_s_2016_13				
Comment Code					
V1 : Control annual grass and weeds on the levee slopes and easements.					
Inspector Comment

Typical vegetation, landside looking upstream.
